Manhole Inspection Summary

Manhole # S11Q__008MH

Insp Date: **4/17/08 1:05 PM**

Location Address: **3101 Strickland St**

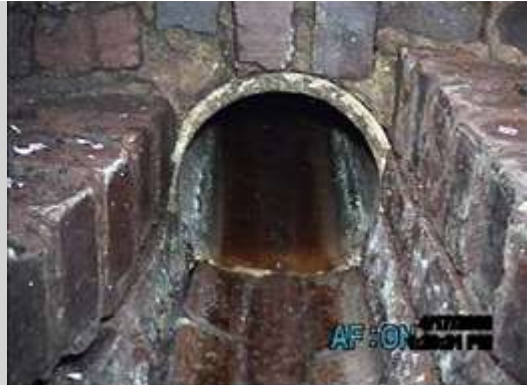
12 O'Clock Outflow

Pipe Height: **7.2** (in.) Rod and Bar (Angled)
Pipe Material: **Clay** ☐ Pipe Lined
Invert Depth: **11.09** (ft.) Flow Characteristics: **Fast**
Deposits: ☒ None ☐ Mud ☐ Sludge ☐ Debris ☐ Grease
Silt Depth: **0** (in.) Deposits Extent:
Infiltration: **None** Pipe Seal Cond: **Sound**

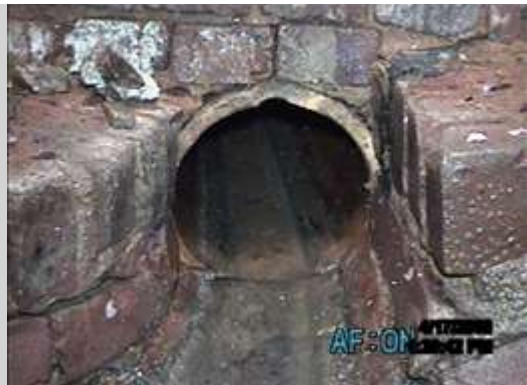
3 O'Clock Inflow

Pipe Height: **7.2** (in.) Rod and Bar (Angled)
Pipe Material: **Clay** ☐ Pipe Lined
Invert Depth: **11.09** (ft.) Flow Characteristics: **Fast**
Deposits: ☒ None ☐ Mud ☐ Sludge ☐ Debris ☐ Grease
Silt Depth: **0** (in.) Deposits Extent:
Infiltration: **None** Pipe Seal Cond: **Sound**

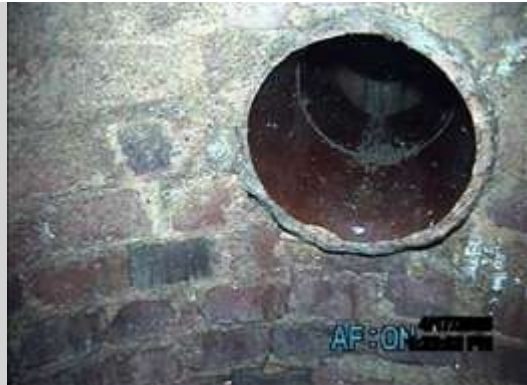
6 O'Clock Inflow

Pipe Height: **8.4** (in.) Rod and Bar (Angled)

Infiltration: **None** Pipe Seal Cond: **Sound**

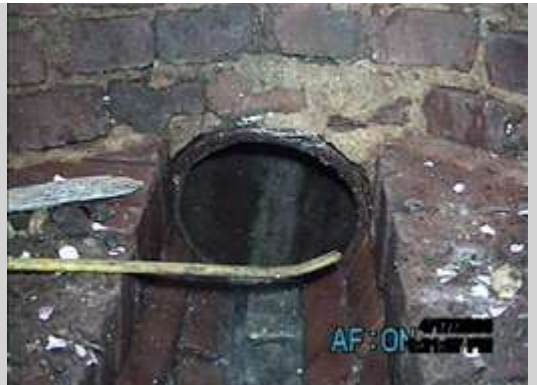
9 O'Clock Inflow

Pipe Height: **7.2** (in.) Rod and Bar (Angled)

Infiltration: **None** Pipe Seal Cond: **Sound**

Drop: Inside	Rod and Bar
Angled: Yes	Reading: 9.76 (ft.)
	Inv Depth: 10.76 (ft.)
Drop Condition: Open
